## Test Report

A 9072-3 / 2009

Contract : Testing of the water-tightness of a sealing system

System HSI 150-K2 packing with installed sealing cover HSI 150-D

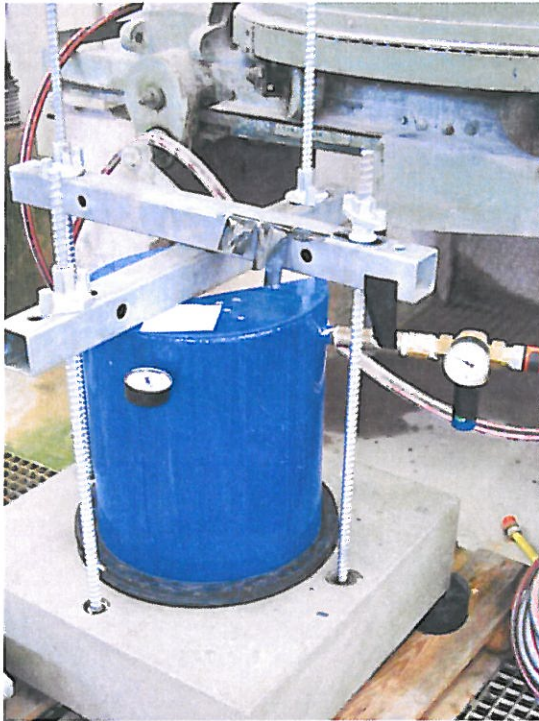
Figure 2: Test setup

Furthermore a compression bell with manometer, pressure regulator and rubber ring seal was provided by the Manufacturer. The compression bell is designated to be put on the test member and pressed against the concrete by four tension rods (see Figure 2).

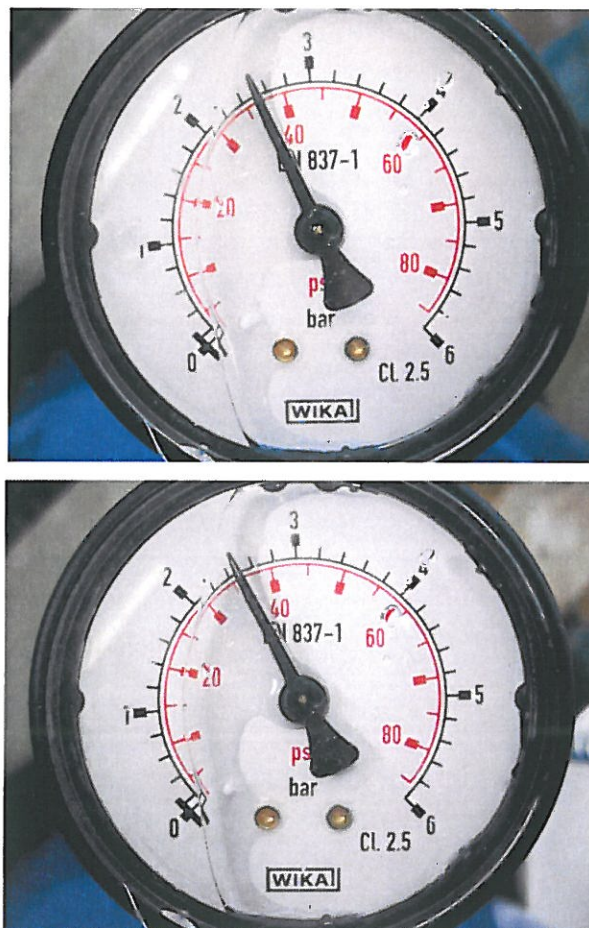
Subsequent the manometer display at the beginning and at the end of the tightness test is shown in Figure 5.

For example causal for the minor pressure decrease may be the hygroscopic properties of the concrete as well as a decrease of the tension force of the tension rods for the pressure bell fixing. A water discharge in the area of the sealing could not be detected.

Figure 5: Tightness test with water filled pressure bell (above: manometer display at the beginning of the test at 11/18/2009 10:15; below: manometer display at the end of the test at 11/19/2009 10:20)
