## Test Report

A 9072-5 / 2009

Contract : Testing of the water-tightness of a cable lead-through

System HSI 150-K2 packing and installed cover system HSI 150-D3/60

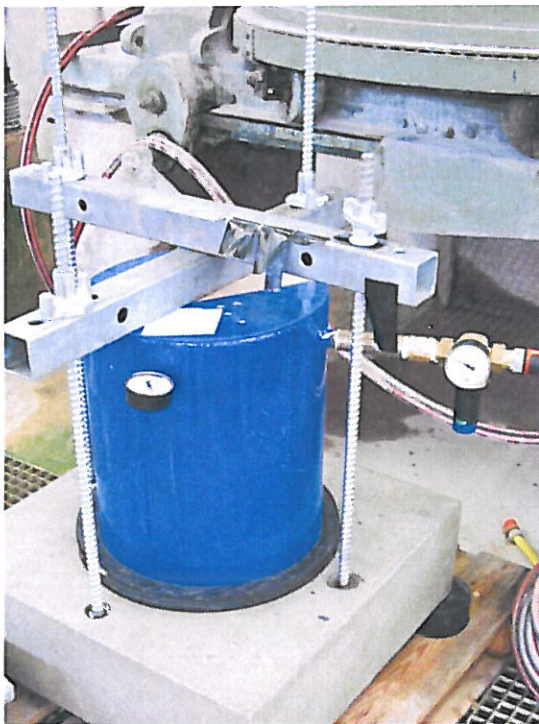
Furthermore a compression bell with manometer, pressure regulator and rubber ring seal was provided by the Manufacturer. The compression bell is designated to be put on the test member and pressed against the concrete by four tension rods (see Figure 2).

Figure 2: Test setup

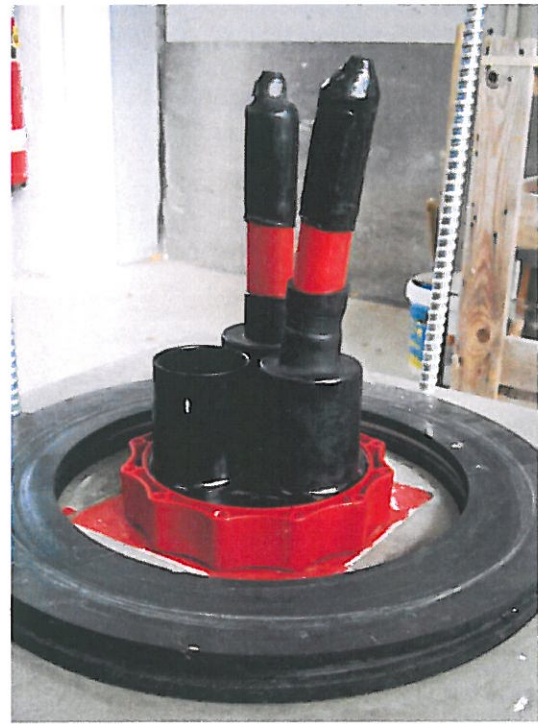
The sealing cover HSI 150-D3/60 was provided with a cold shrink sleeve, a heat shrink sleeve and a sealing plug. In each of the two shrink sleeves cables with  $\varnothing$  35 mm were installed (see Figure 3). For the protection and the sealing shrink-on sleeves were put on the end of the cables. The shrink-on sleeves were installed according to the Manufacturer instructions.

Figure 3: Test specimen

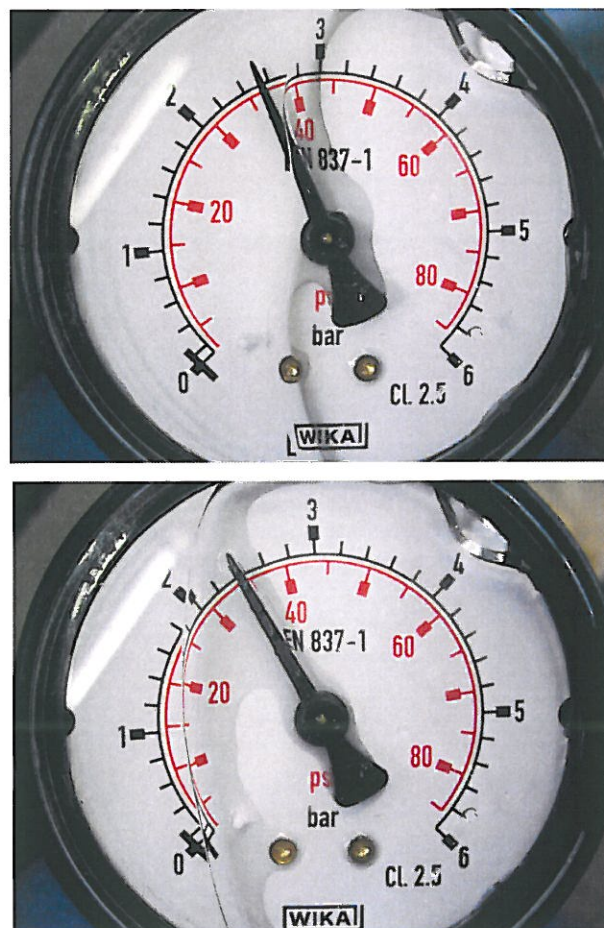
Subsequent the manometer display at the beginning and at the end of the tightness test is shown in Figure 5.

For example causal for the minor pressure decrease may be the hygroscopic properties of the concrete as well as a decrease of the tension force of the tension rods for the pressure bell fixing. A water discharge in the area of the sealing could not be detected.

Figure 5: Tightness test with water filled pressure bell (above: manometer display at the beginning of the test at 11/23/2009 12:20; below: manometer display at the end of the test at 11/24/2009 12:25)
