Test Report

Hauff-Technik GmbH & Co. KG
Giengener Straße 35
89428 Syrgenstein - Landshausen

Contract : Testing of the water-tightness of a cable lead-through

System HSI 150-K2 packing with installed cable entry system KES-M 150-D

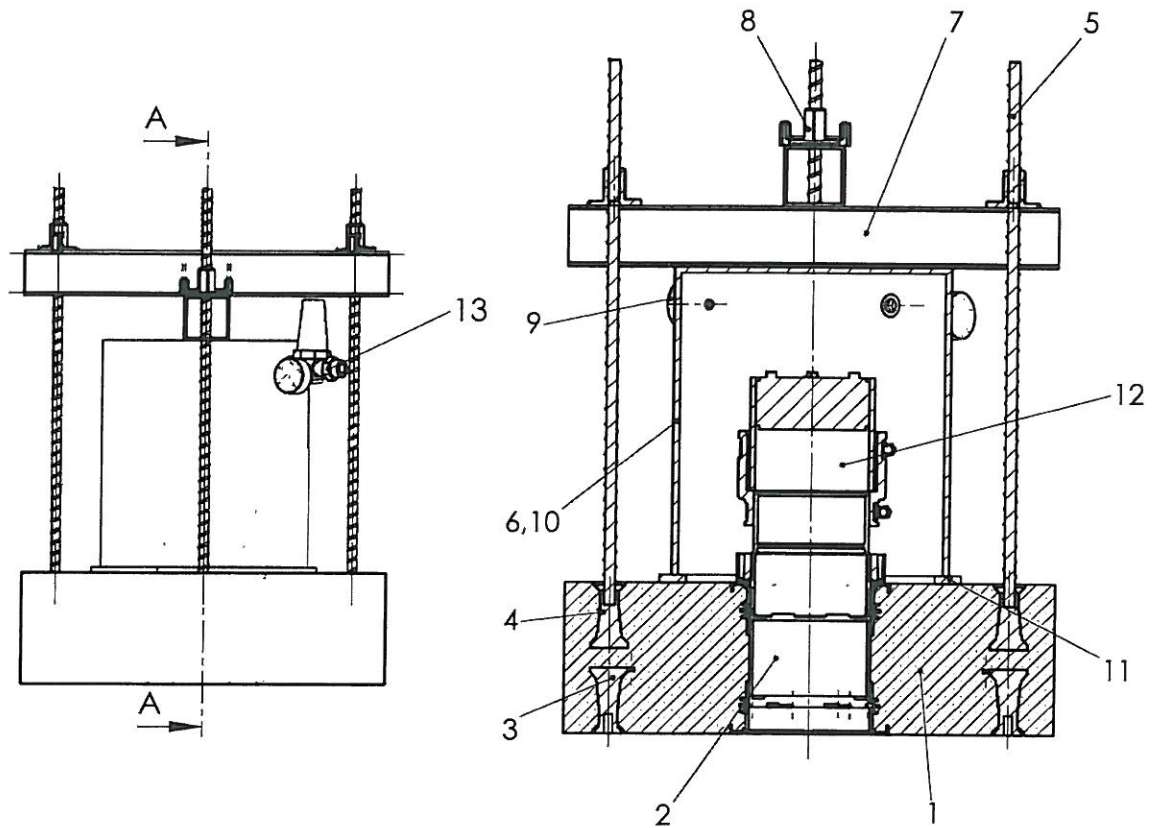
Figure 4: Test setup (Manufacturer drawing)

Item	Designation	Standard	Material
13	Pressure reducing regulator		
12	KES M150-D		EPDM 55+/- Shore A
11	Rubber seal		
10	Bleed valve		
9	Pressure gauge		
8	Spindle rod nut		1.4301
7	Square tube		1.4301
6	Pressure cap welded part		St37
5	Formwork ties		
4	Climax protective cover		
3	Climax sleeve with nail cap		
2	HIS 150-K2/200		
1	Touchstone		C35 / C45 Concrete

The test member which was delivered by the Manufacturer was a pre-assembled concrete test member with a test setup in accordance with section 2.1 and with a pre-assembled manometer and pressure regulator (see Figure 2 to Figure 4). A calibration of the manometer and the pressure regulator was not carried out by Kiwa Bautest GmbH.

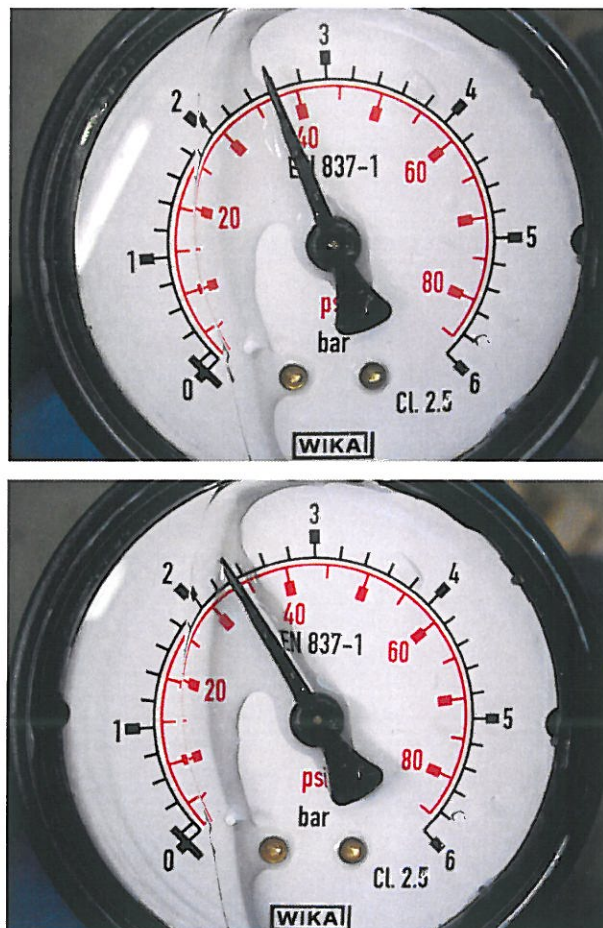
Figure 5: Tightness test with water filled pressure bell (above: manometer display at the beginning of the test at 11/24/2009 14:20; below: manometer display at the end of the test at 11/25/2009 14:20)

Subsequent the manometer display at the beginning and at the end of the tightness test is shown in Figure 5.

For example causal for the minor pressure decrease may be the hygroscopic properties of the concrete as well as a decrease of the tension force of the tension rods for the pressure bell fixing. A water discharge in the area of the sealing could not be detected.

During the tightness test (double packing HSI 150-K2 with installed cable entry system KES-M 150-D) with water filled pressure bell with a nominal pressure of 2,5 bar no defect in water tightness as a result of water discharge could be detected.
