Project / Plant: Building entry system Hauff MSH PolySafe with the outer sealing element module 1.2 installed in a wall sleeve of a test block with exterior waterproofing PCI Pecimor 2K (waterproofing class W2.1E according to DIN 18533-1)

Product description: Building entry system Hauff MSH PolySafe with the outer sealing element module 1.2

Order: ≥ 1,0 bar water tightness test for 28 days

Remark: Translation of Test Report A1742022-01,
11 June 2018

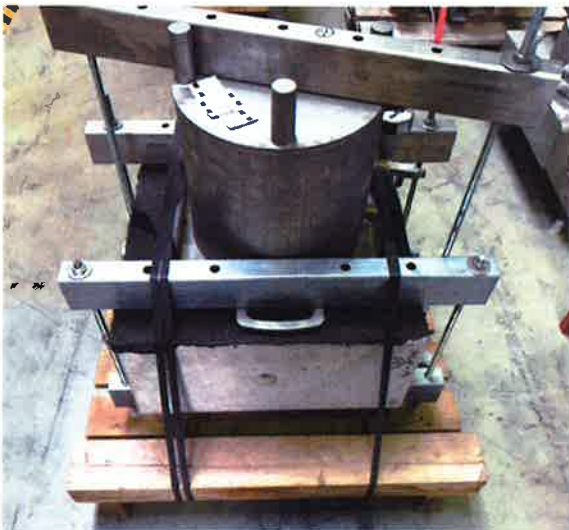
Figure 1. Assembled test setup.

Therefore Hauff-Technik GmbH & Co. KG delivered the test block with the already installed building entry system Hauff MSH PolySafe with the outer sealing element module 1.2 together with the components for the test setup to our test laboratory in Gersthofen, Germany. The surface of the test block which was charged with water pressure was already finished with exterior waterproofing PMBC PCI Pecimor 2K [4] according to DIN EN 15814 [5]. The assembly of the test setup was performed by an employee of Hauff-Technik GmbH & Co. KG (see Figure 1).

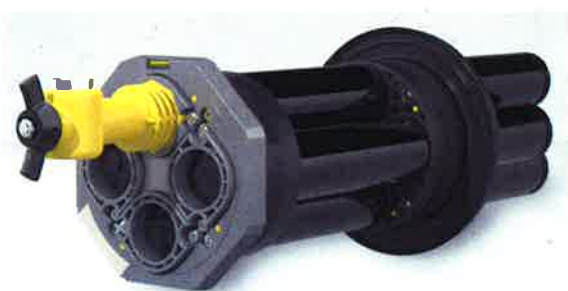
Figure 2. Example for a MSH PolySafe building entry system basic variant (picture of the manufacturer).

After hardening of the exterior waterproofing the sleeve pipes of the MSH building entry system (see Figure 2) were spread with plenty of lubricant and the building entry system was set in the wall sleeve via the side of the test block which is not charged with water pressure. After that the outer sealing element module 1.2 was assembled from the outer sealing element module 1 and module 2 with four internal hex screws (Figure 3) so that the two spacers are mounted on the outer sealing element module 1.

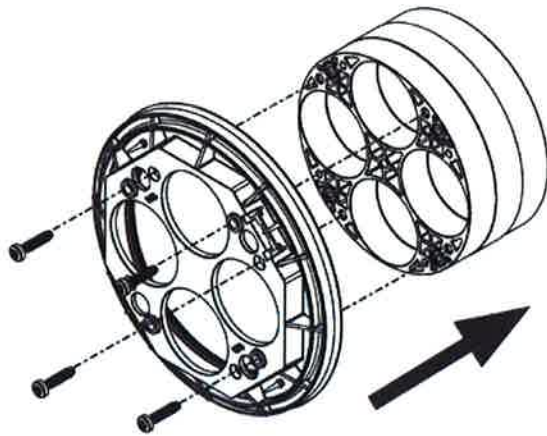
Figure 3. Example of the MSH PolySafe outer sealing element module 1.2 (consisting of MSH PolySafe outer sealing element module 1 and 2) (picture of the manufacturer).

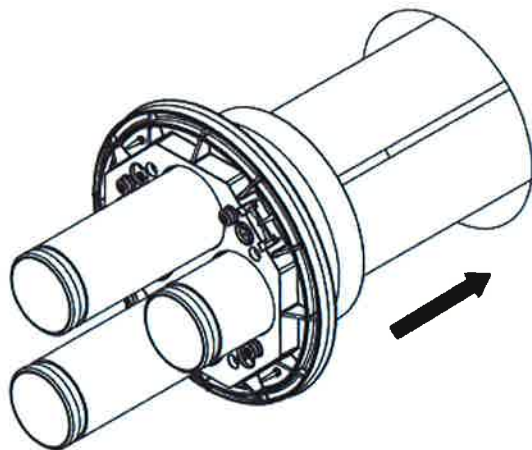
Figure 4. Example for pushing the outer sealing element module 1.2 over the sleeve pipes against the outside wall (picture of the manufacturer).

After spreading lubricant on the internal sealing surface of the outer sealing element module 1.2 the sealing module was pushed over the sleeve pipes as far as possible against the side of the test block which is charged with water pressure (see Figure 4). Thereon the four internal hex screws of the outer sealing element module 1.2 were tighten crosswise until the control pins were flush with the front panel of module 1 or a torque of 14 Nm was reached. After removing both spacers the internal hex screws were tighten crosswise again until there was a perceptible tension of the sealing lip around the flange.

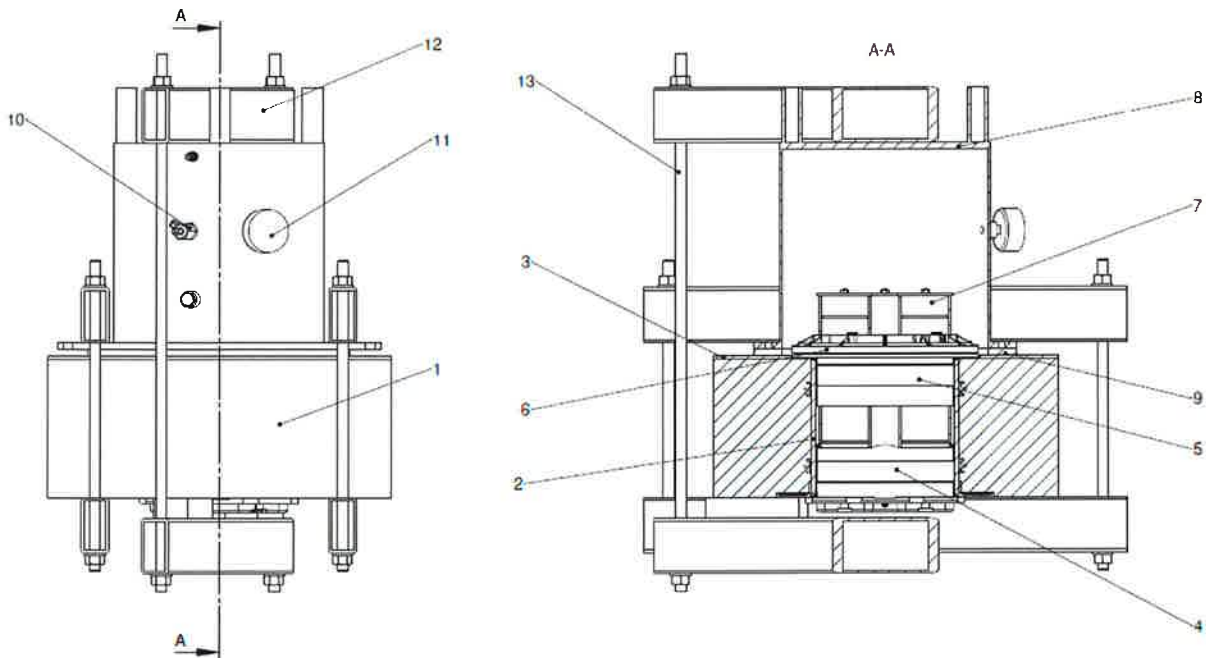
Position	Designation
Pos. 1	test block
Pos. 2	wall sleeve
Pos. 3	polymer modified bituminous coating (PMBC)
Pos. 4	MSH building entry system
Pos. 5	MSH PolySafe outer sealing element module 1
Pos. 6	MSH PolySafe outer sealing element module 2
Pos. 7	press seal for pipe sealing
Pos. 8	test cylinder
Pos. 9	test cylinder seal
Pos. 10	stop valve
Pos. 11	pressure gauge manometer
Pos. 12	security bar
Pos. 13	threaded rod

Figure 5. Detail of the test setup - manufacturer's drawing.

The test setup which was assembled by Hauff-Technik GmbH & Co. KG was built up in accordance to Section 3.1 with one manometer (see Figure 5).

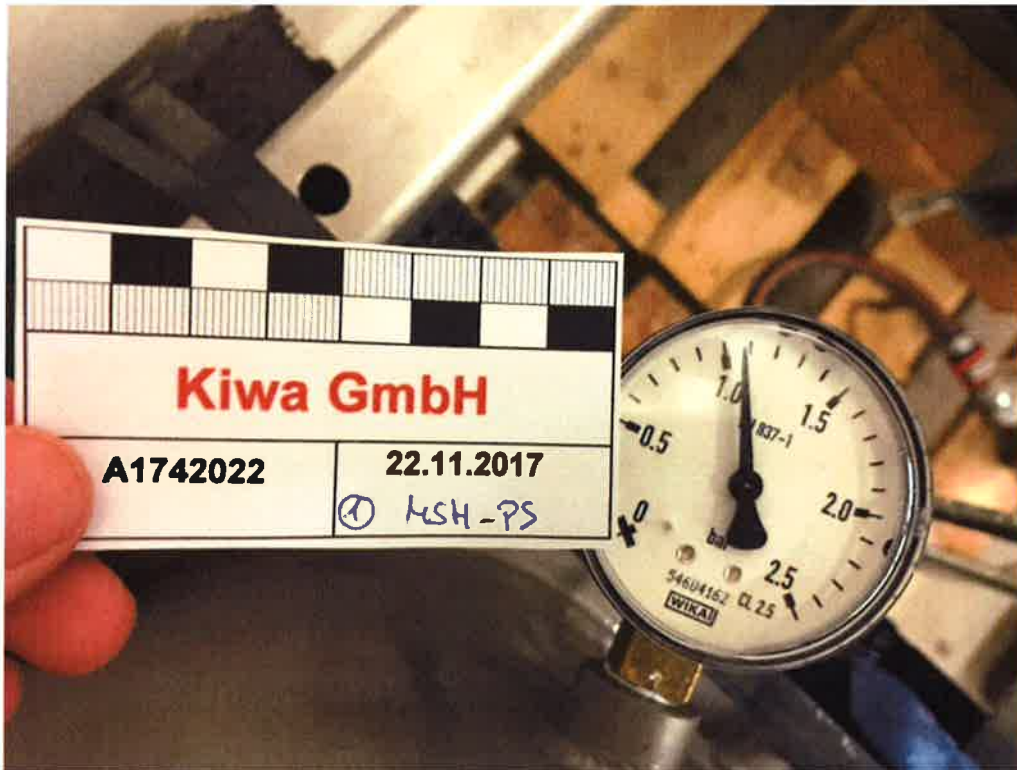
Figure A1. Water tightness test with $\geq 1,0$ bar water filled test cylinder (manometer at the beginning of testing on 22.11.2017).

During the water tightness test no pressure drop as a result of leakages was detected (see Table 1). The test results can be seen at Figure A1 and Figure A2 attached in the annex.

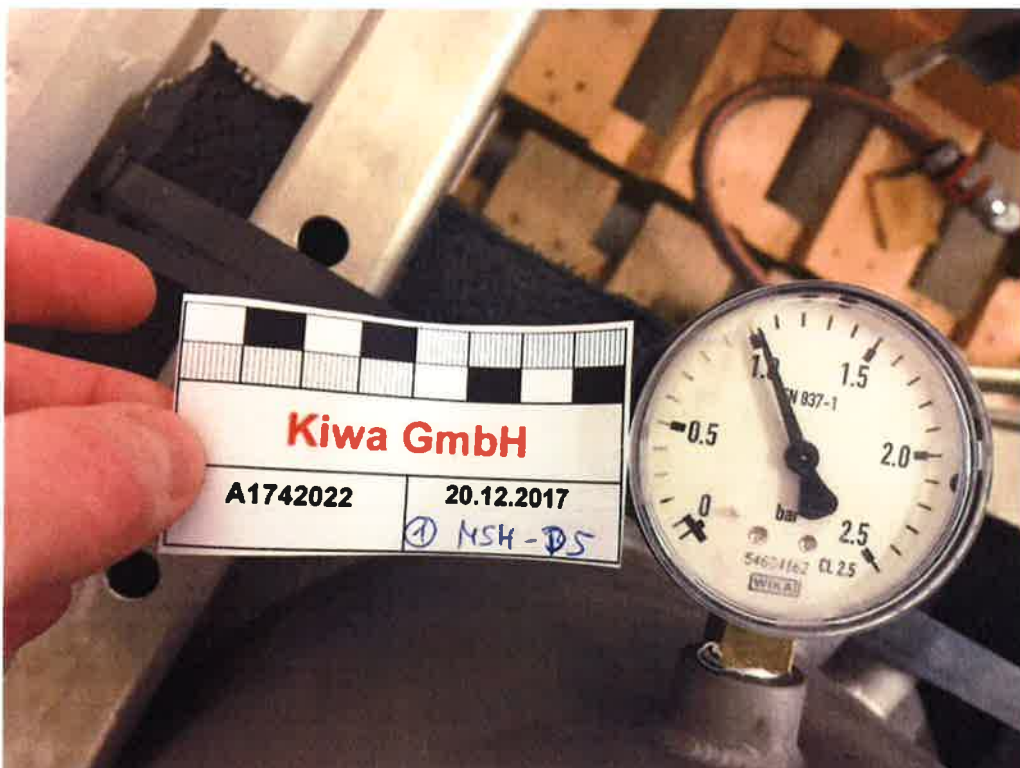
Figure A2. Water tightness test with $\geq 1,0$ bar water filled test cylinder (manometer after 28 days on 20.12.2017).
